A RESOLUTION BY THE BOARD OF COUNTY COMMISSIONERS OF ST. JOHNS COUNTY, FLORIDA, APPROVING THE TERMS AND AUTHORIZING THE COUNTY ADMINISTRATOR, OR DESIGNEE, TO SUBMIT A LONG RANGE BEACH EROSION CONTROL BUDGET PLAN WITH THE DEPARTMENT OF ENVIRONMENTAL PROTECTION, BUREAU OF BEACHES AND COASTAL SYSTEMS.

FLORIDA DEPARTMENT OF ENVIRONMENTAL PROTECTION
FY2019/20 Local Government Funding Request
Inlet Projects Application

1. Project Name: (as listed in the Inlet Management Plan (IMP) or Strategic Beach Management Plan (SBMP)). Porpoise Point Feasibility Study

Trip Report

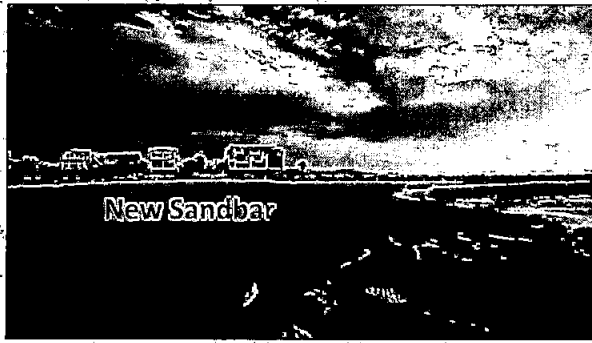
Moving westward along the groin to about where the ocean front houses start north of the groin, a very porous section of the groin was observed. A newly formed sandbar was observed extending southward into the inlet from this point which curved to the southwest as it extended into the inlet. (See pictures below)

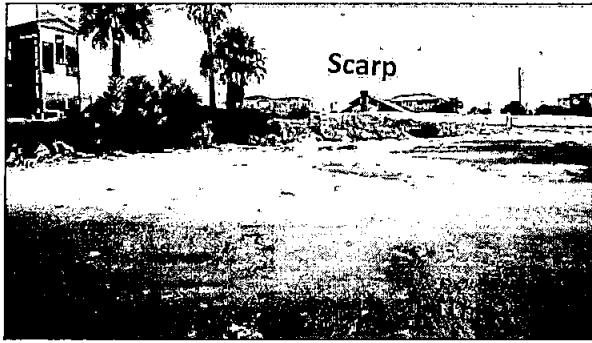
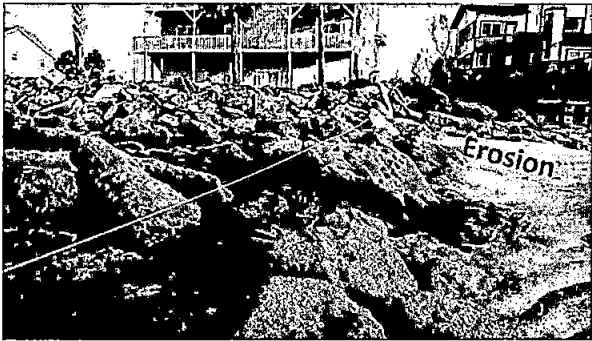
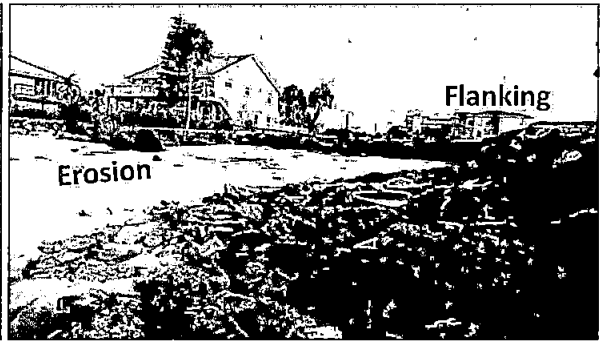
Increased erosion was observed along the armor fronting the easternmost homes south of the groin. The sand placed at the eastern end of Porpoise Point Drive several months ago appears to be mostly in place other than a scarped area at the southwestern end of the placed material. The shoreline armor at the second house in from the east was getting flanked to the west with erosion encroaching into the yard. This location is currently the most vulnerable area to property damage should a storm impact this area. (See pictures below)

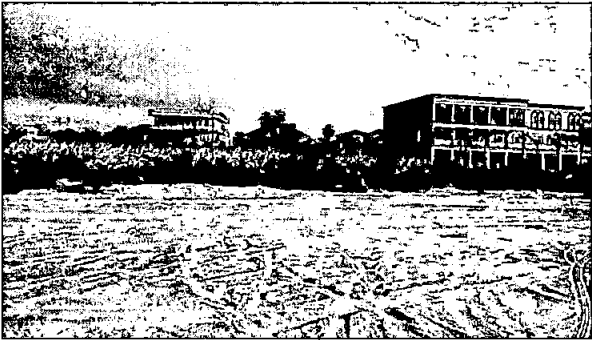
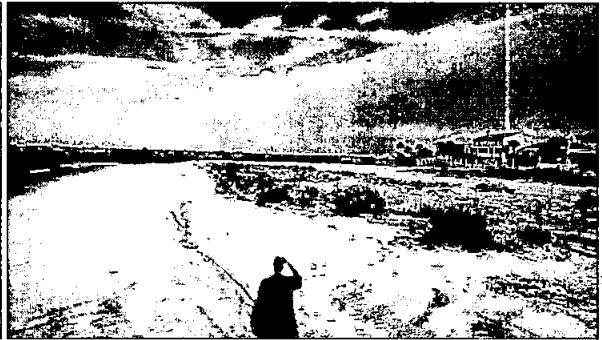
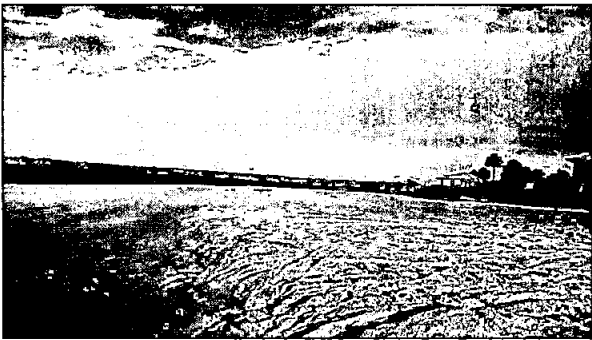
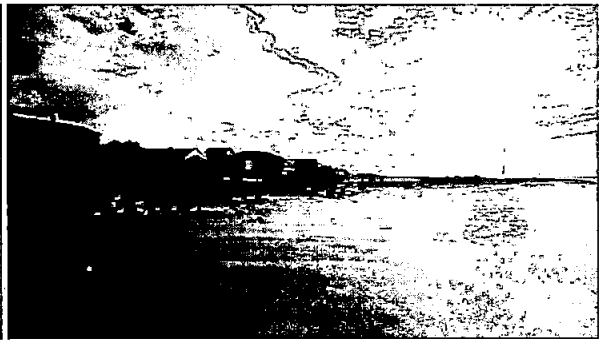
Continuing to the west, the Porpoise Point shoreline had a wider dry portion of vegetated dunes between the homes and the inlet, however the dune area was still narrower than it was prior to Hurricanes Matthew and Irma. Sand appears to be migrating to the west towards the IWW and there is now dry beach underneath the boat lift at the southwest corner of Porpoise Point. (See pictures below)

It is possible that the newly formed sandbar will continue to migrate towards the Porpoise Point shoreline where it will build the dry beach fronting the homes inside of the groin. The area still remains vulnerable to damages from storm impacts. Homeowners should remain vigilant and continue to report changing conditions in the area.

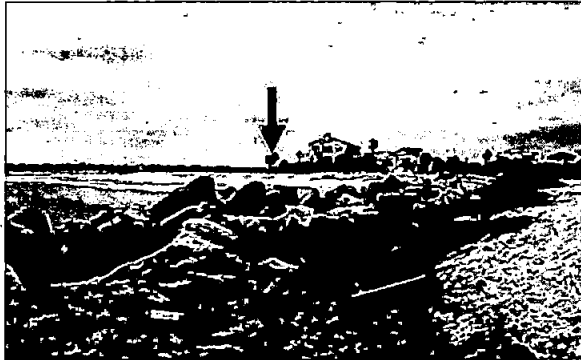
November 14, 2017

Photo comparison to previous site visits

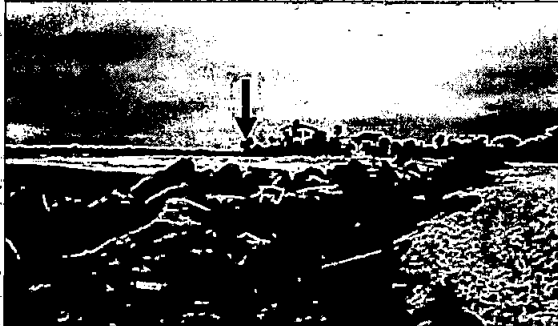
November 14, 2017

The site visit began at the landward end of the groin (seaward end of Porpoise Point Drive) where recent erosion has progressed further landward along the south side of the groin. This was the worst erosion anyone on site had ever seen in this location. Erosion had encroached upon the landward side of the groin which had previously been covered by sand and vegetation, and had already undermined the most seaward end of Porpoise Point Drive, encroaching upon the seaward most homes on the south side of Porpoise Point Drive. The below pictures show the erosion observed on the site visit compared to previous site visits within the past year.

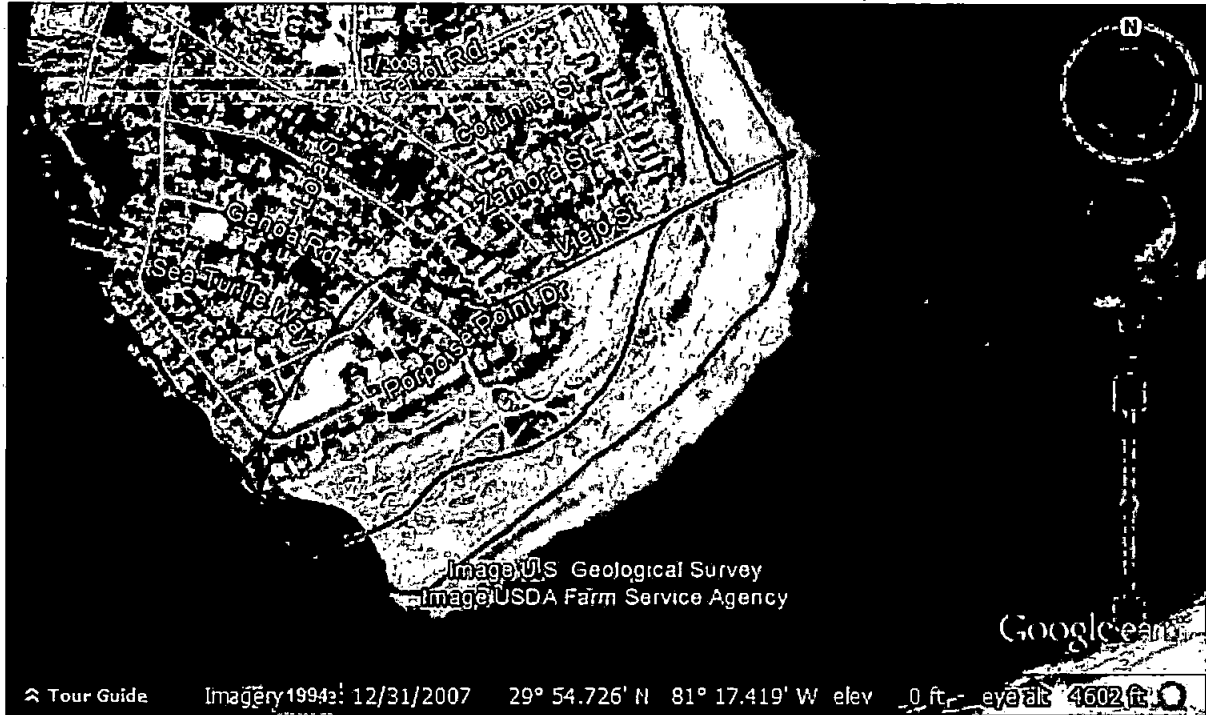
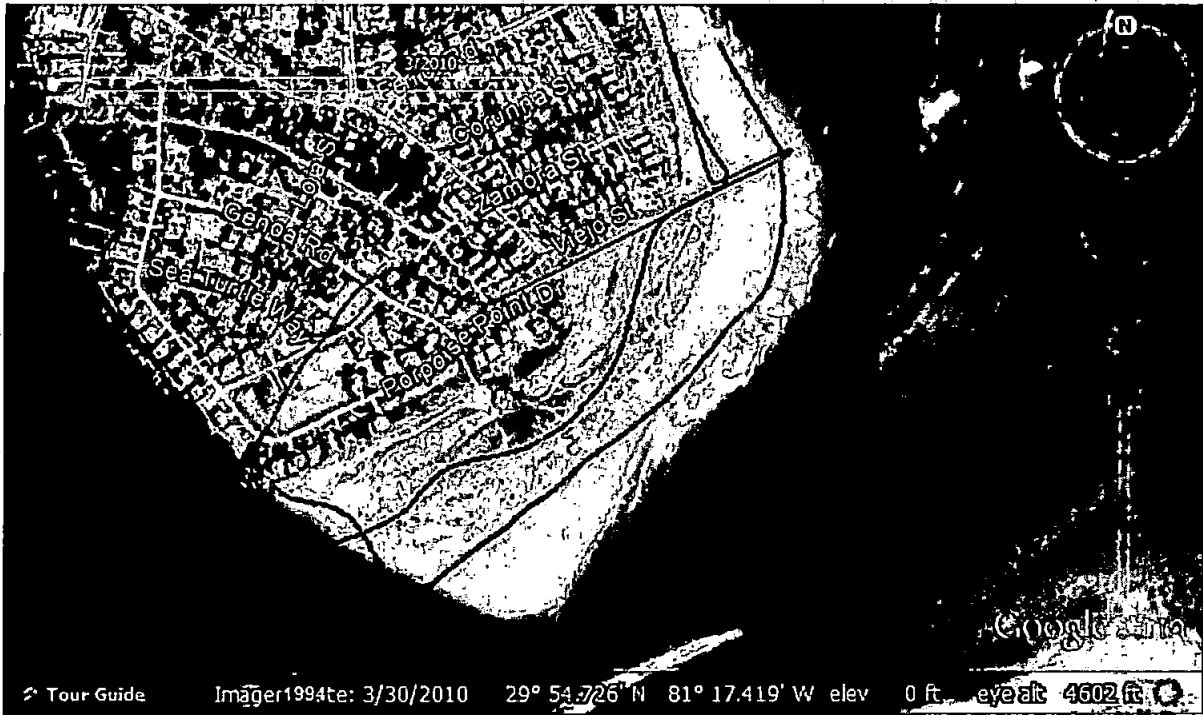
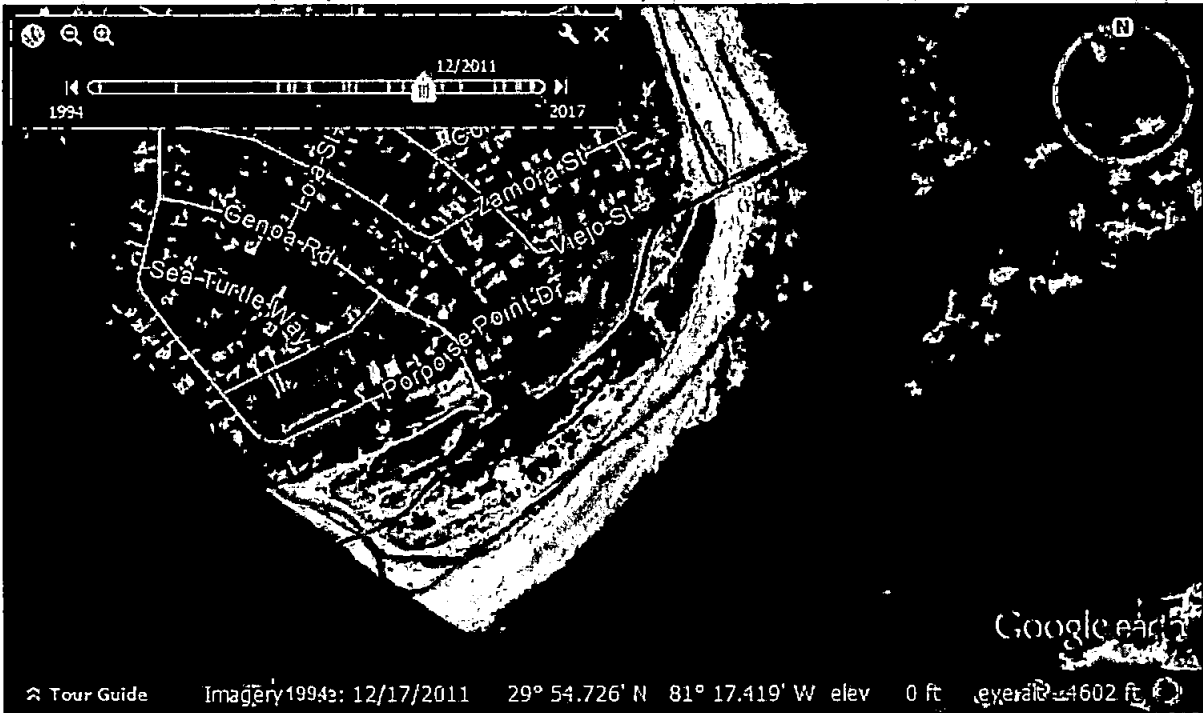
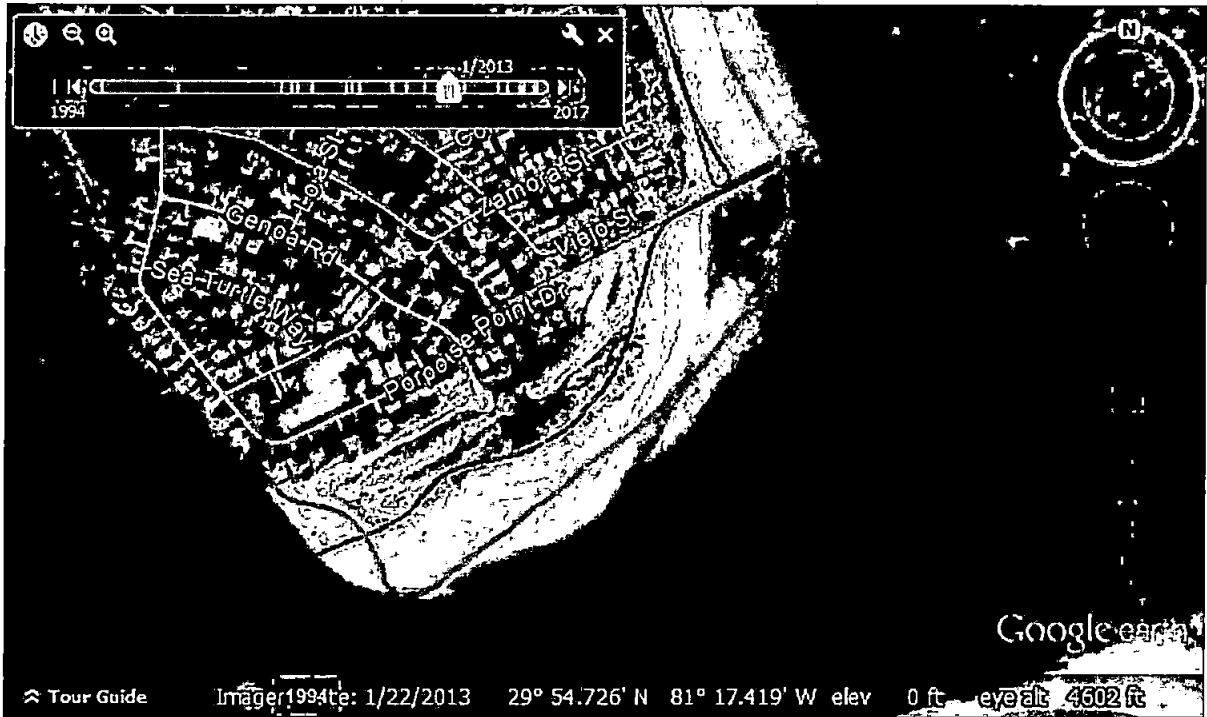
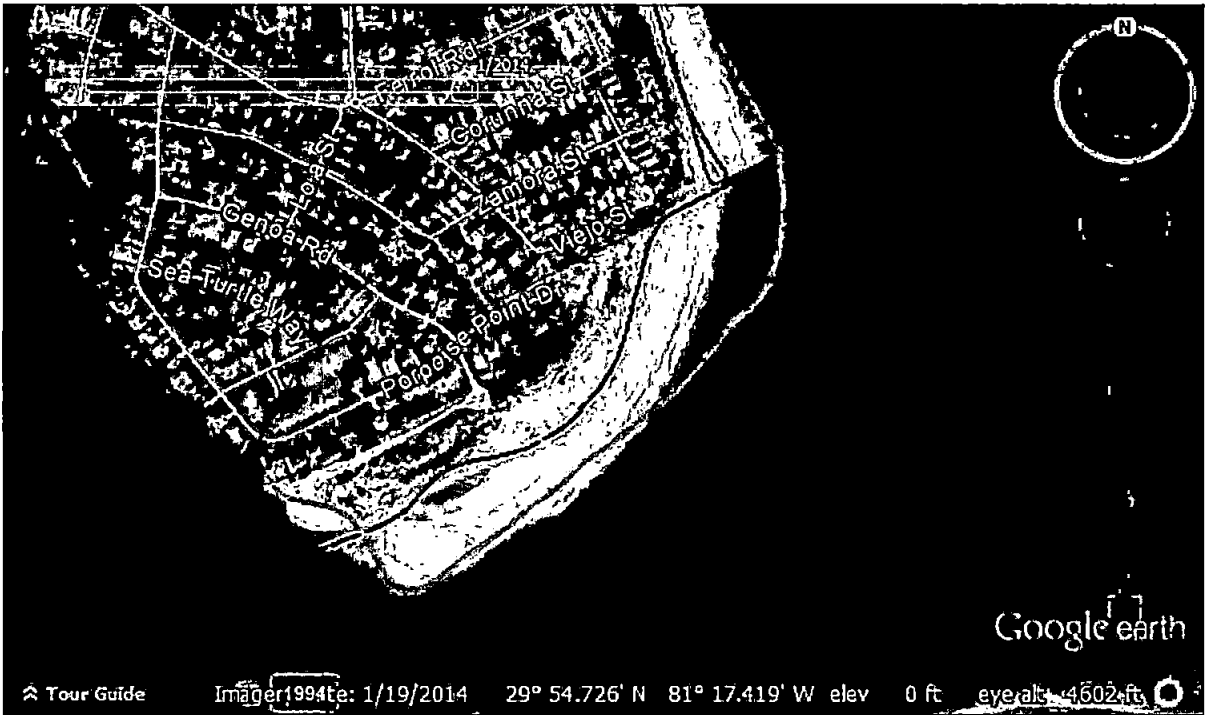
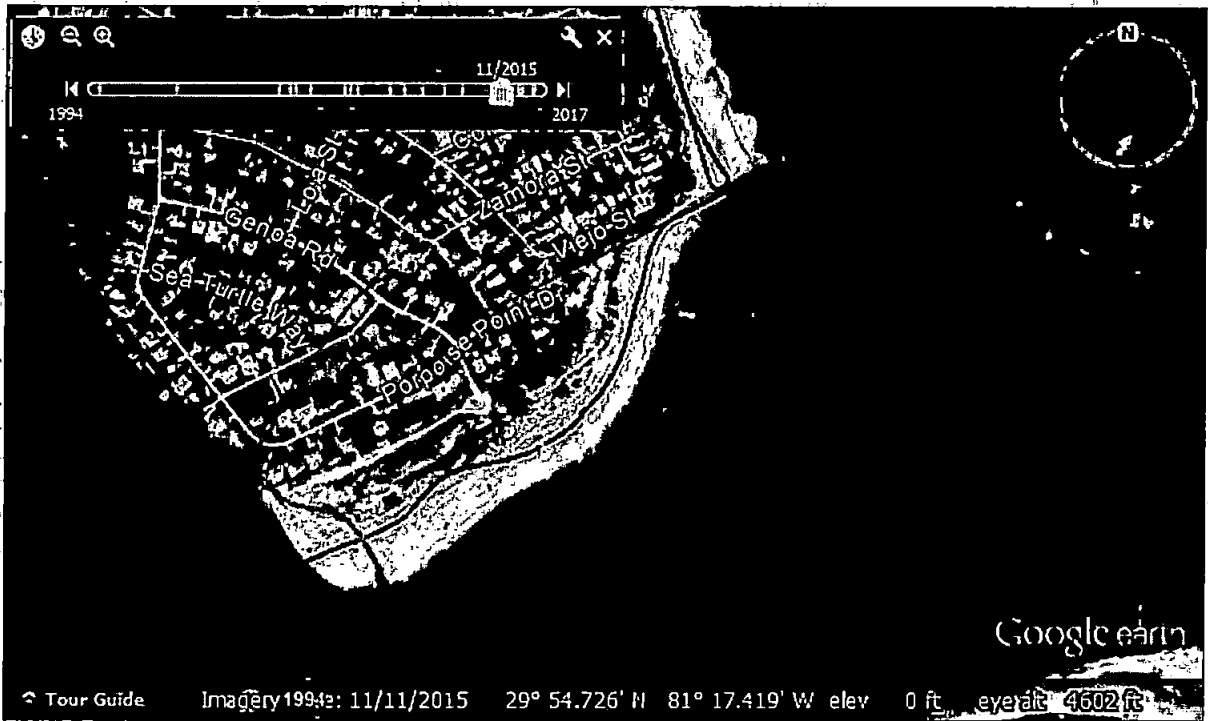
- **Changes to the inlet hydraulics:** The interaction between the Porpoise Point shoreline and the tidal current flowing through the inlet may have experienced a change in recent years potentially attributable to dredging areas in 2012 that were not previously used as borrow areas. This along with other factors such as recent storm events may have altered the inlet hydraulics and may be contributing to the increased erosion of Porpoise Point now being observed.

- **Storm impacts:** Porpoise Point and the vicinity of the north groin experienced significant overtopping during both Hurricanes Matthew (2016) and Irma (2017) and the beach immediately to the north appeared to experience erosion during both of these events. Following Irma a stretch of nor'easter conditions continued to erode the shoreline in this area.

The following series of screen shots of Google Earth imagery shows gradual erosion of Porpoise Point since 2008 when the shoreline at the seaward end of the north groin was at its widest point based on LIDAR data available going back to 1999. In all of the screen shots the 1946 MHW line (3 years after groin construction completed) is shown in red, the 2008 MHW line (widest Porpoise Point has been recently at the end of the groin) is shown in green, and the 2017 MHW line (post-Irma) is shown in blue. The imagery dates are shown at the bottom of the screen shots.

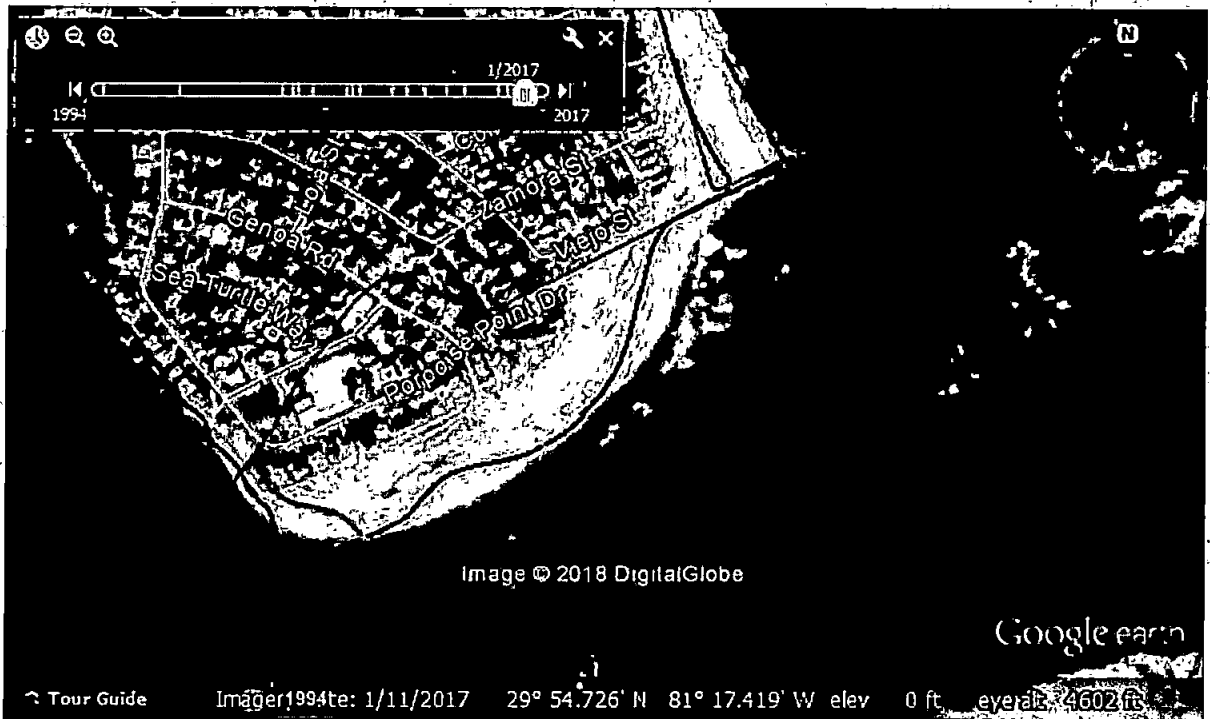
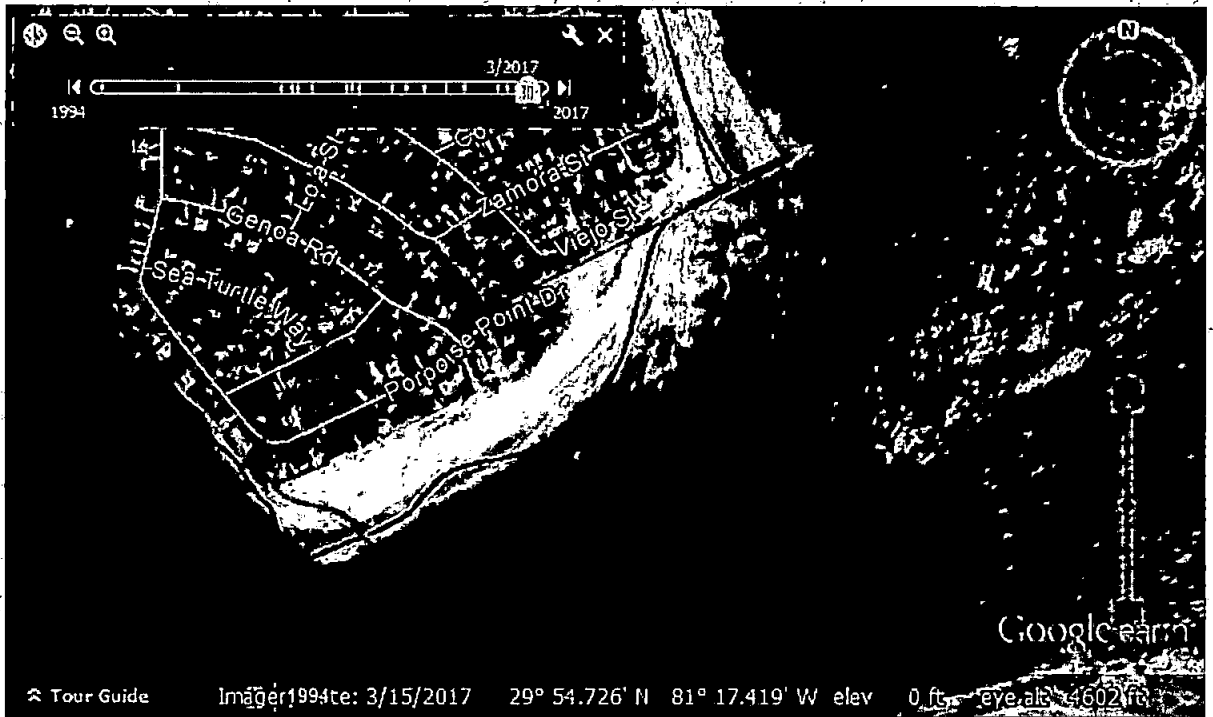
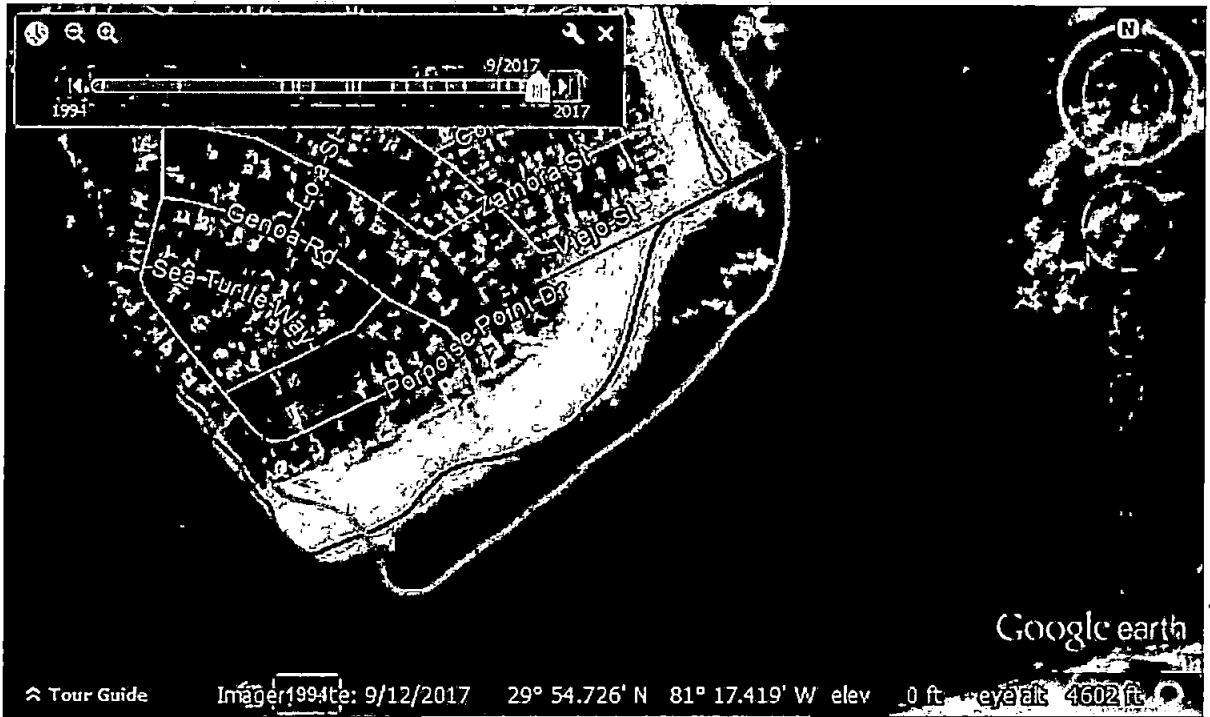
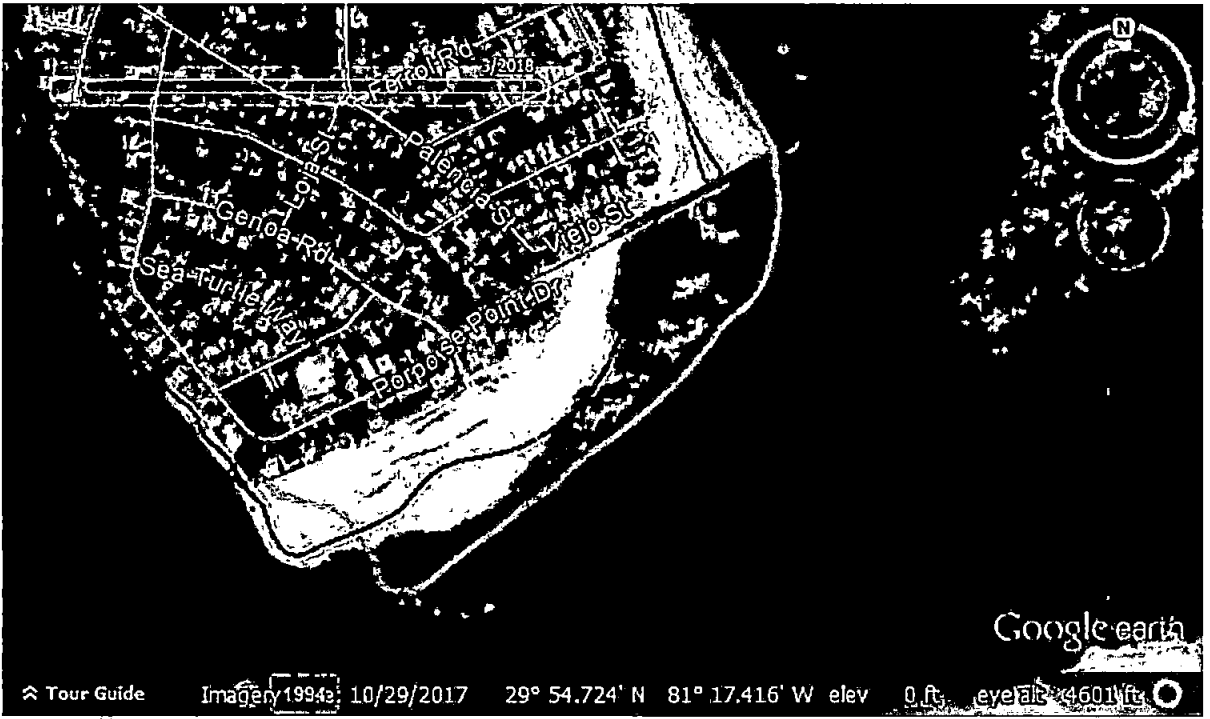
Observations and Discussion on Proposed Partial Sand Tightening

In addition to inspecting the increased erosion on the south side of the groin, the team also discussed the extent for partially sand tightening the groin. Partial sand tightening of the exposed structure is the recommendation that came from investigating possible modifications to the groin using the Coastal Modeling System (CMS) and subsequent discussions with stakeholders. We will also try to include backfilling the groin with additional sand as part of the project construction to ensure that the improved structure doesn't reduce the amount of sediment transported past the structure.

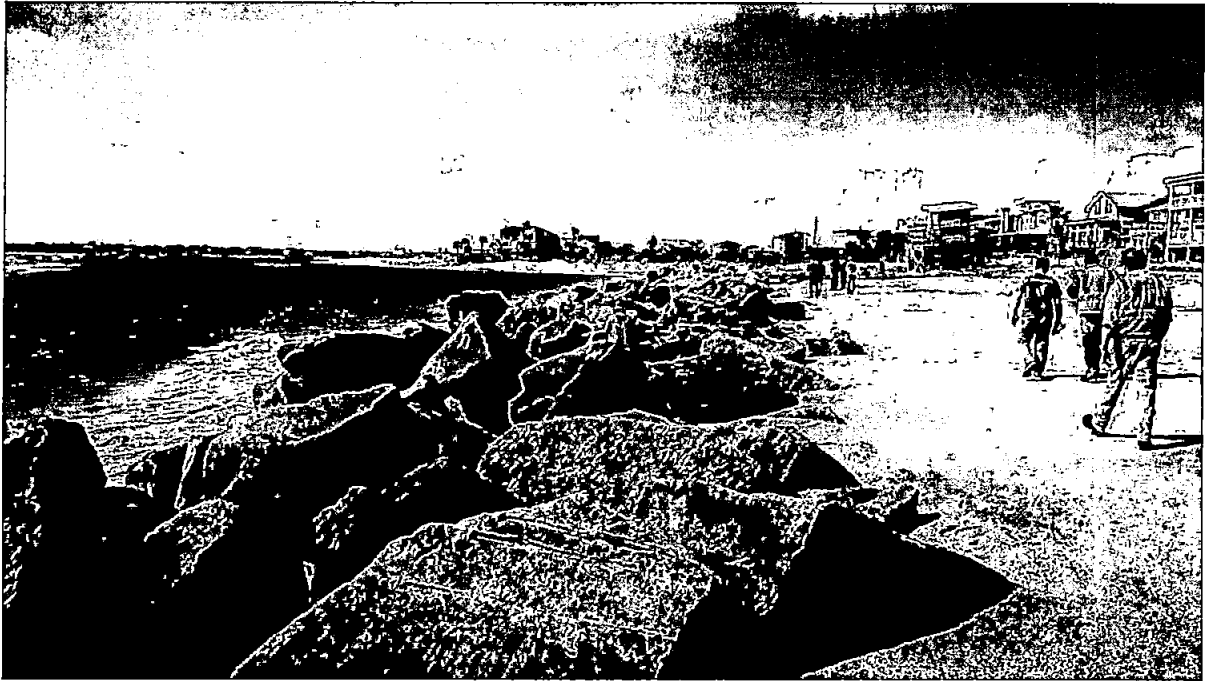
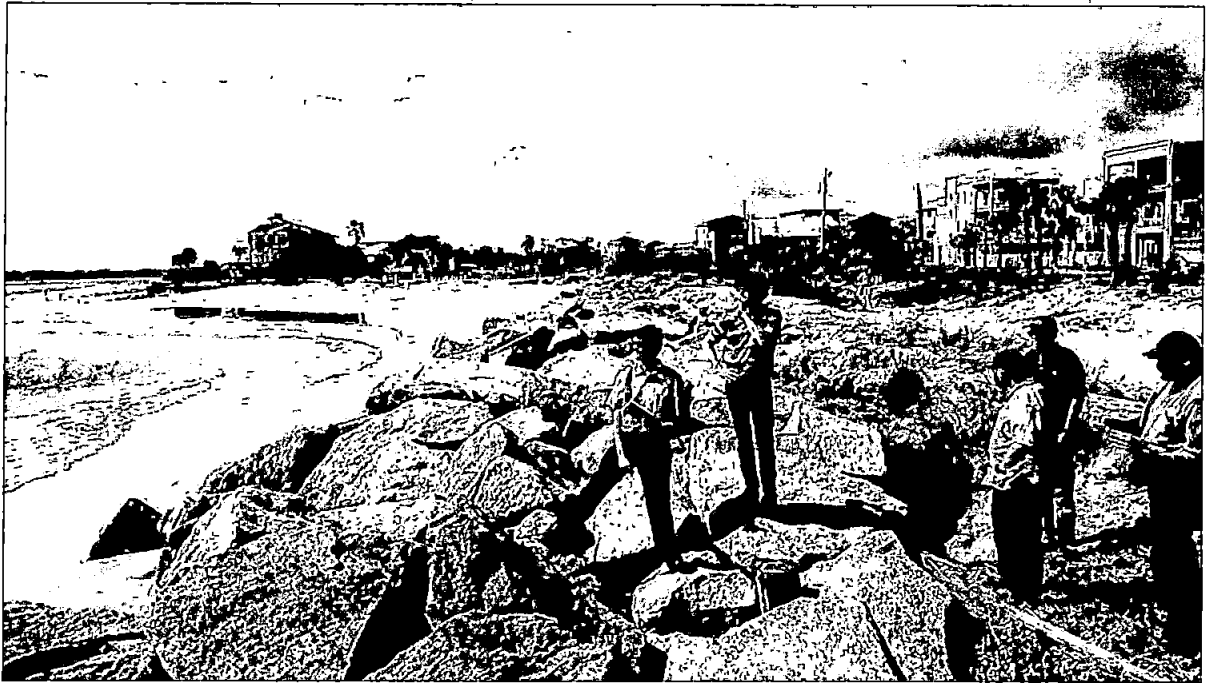
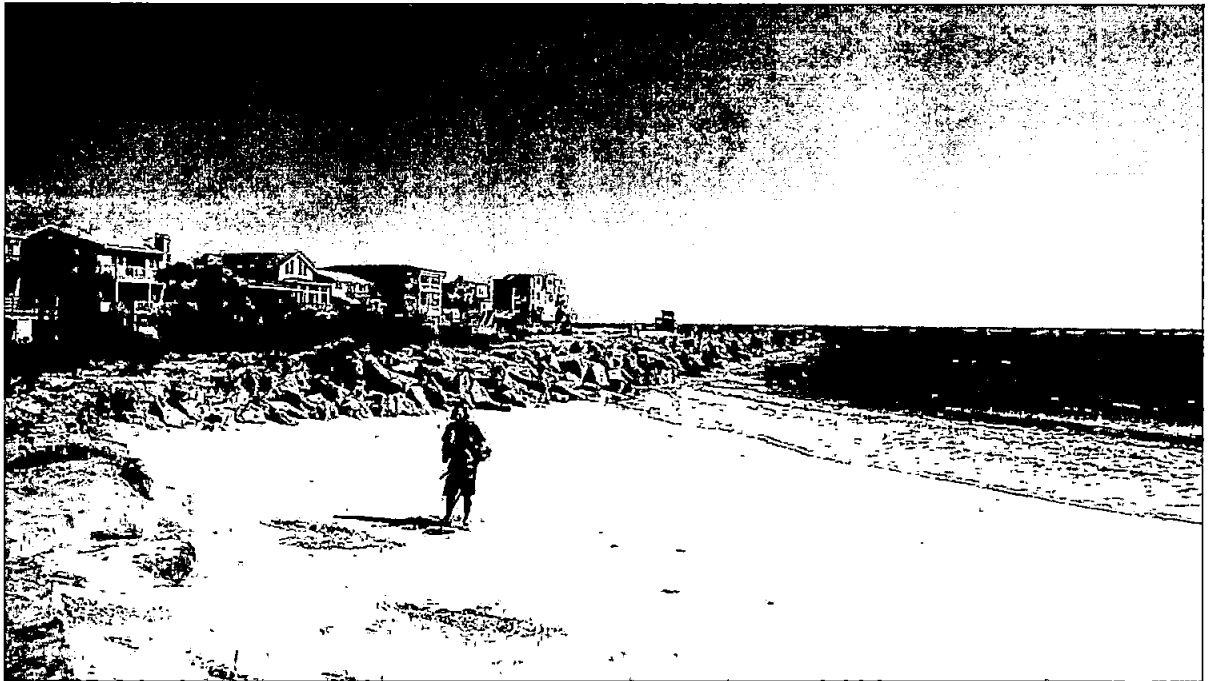
The below pictures show the general condition of the groin where sand tightening is proposed.

- The seaward and landward extents of the sand tightening
- Work within the USACE easement from the north (landward) side of the groin
- Removal of the existing timber piles
- NEPA will require an EA and due to proximity of water may require a permit
